## Case Study

# Radiator Performance

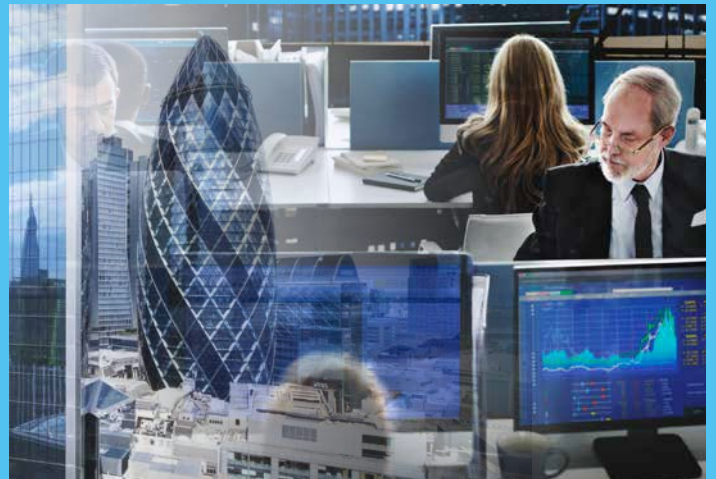
While the load-bank test went without fault, the cooling temperatures measured by our cooling specialist were far higher than expected for the measured ambient conditions. A cross functional team was pulled together to deep dive the problem with the following conclusions being drawn.

A review of the original O&M manual highlighted that the cooling system had been designed around a maximum predicted ambient temperature of 25°C. The maximum recorded ambient temperature for July 2018 was almost 34 degrees C

When the building was originally built in the early 1980's it was one of the highest in the surrounding area and was not overlooked by other tall buildings. By 2018 this is no longer the case, and the building is one of the shorter buildings in the area. Added to this a building makeover in the last 10 years has resulted in the top floors having a glass surround added to modernize the building. A combination of these two mean the actual temperatures on the building roof are now considerably higher than they were back when the cooling equipment was first commissioned

During the summer of 2019 a new horizontal cooler was installed on the roof, capable of achieving a higher ambient clearance. Load-bank testing at the end of the summer gave a predicted maximum ambient clearance of 39 degrees C, ample clearance for the temperatures currently being recorded in London
